## Revised notice of an error in pressure calibration of Argo Program CTDs manufactured between September 2015 and June 2018

### Summary

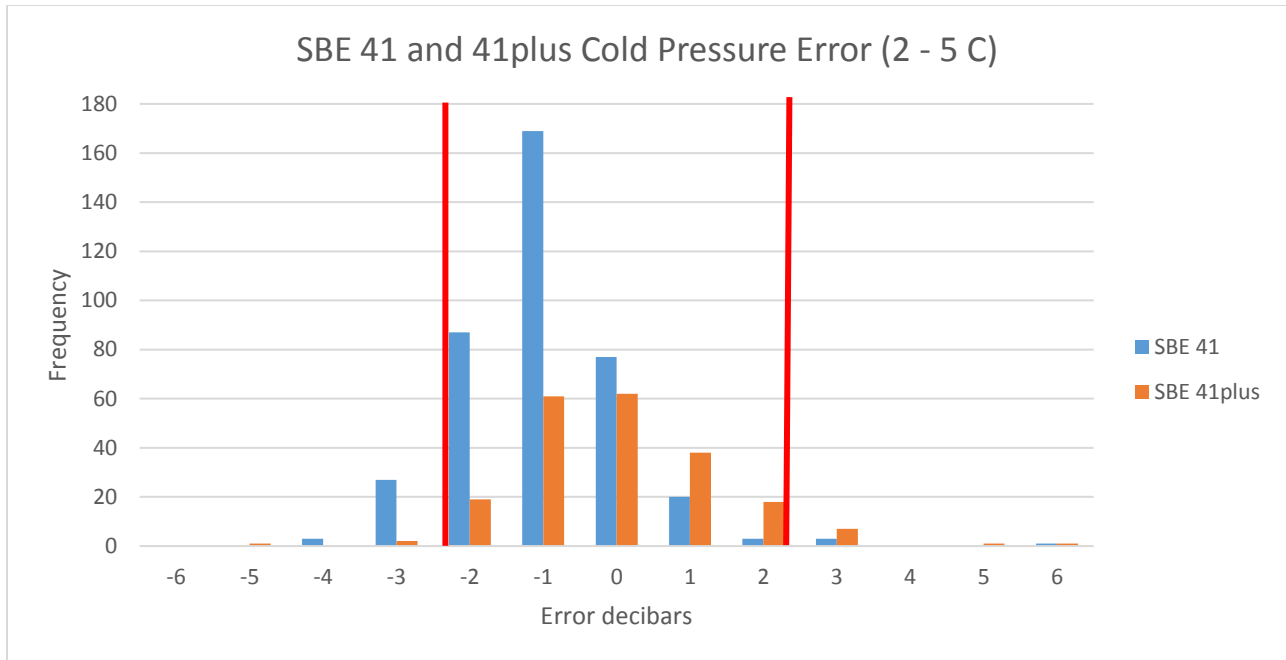
As can be seen in Table 3 and Figure 1, in spite of the introduction of a bug in the 41plus the overall pressure performance has improved over the SBE 41. Previous efforts to improve the pass rates of pressure acceptance testing have focused on the pressure sensor temperature response model. Progress made in this effort are reflected in the better performance of the 41plus.

Figure 1, histograms of pressure error for SBE 41s tested between January 2011 and December 2013 and SBE 41plus tested between January of 2014 and December 2017. The red lines indicate the pressure sensor accuracy specification of +/- 2 decibars.
