From: Dana Swift
To: Webb Research, Pete Furze
Date: October 31, 2017
Subject: **Hypothesis: Hull corrosion as an AWOL failure mechanism for APEX.**

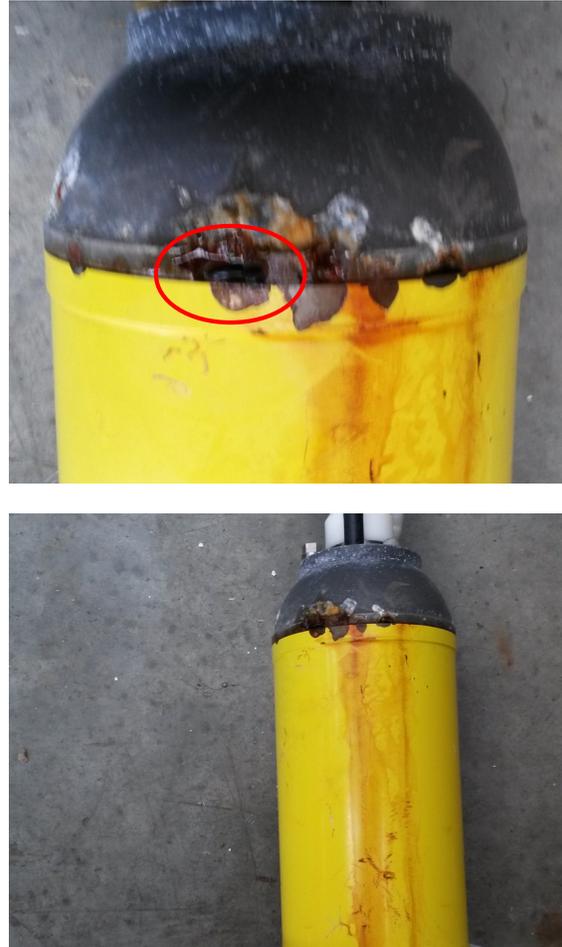
This is PMEL's Apex (WrcId) 3020 that was deployed in the South Pacific in February, 2007. The float functioned for only 58 profiles before it drifted into shallow water and became stuck to the bottom (~850m) of the ocean in October, 2008. In July, 2015, the float was recovered from the seafloor by a fishing trawler and transported to port in New Zealand.

The region inside the red ellipse in the top image reveals corrosive erosion so severe that the o-ring has been exposed. The loss of containment resulted in the flooding of the float. The contact in New Zealand reported that no trace of the anode remained.

Figure 1: PMEL Apex 3020 was recovered from the ocean bottom by a fish trawler. *Upper:* The region inside the red ellipse reveals corrosive erosion so severe that the o-ring has been exposed. The loss of containment resulted in flooding of the float. *Lower:* The painted hull appears to be unaffected by corrosion. The redish discoloration suggests rust that leaked out from inside the float.

If confirmed, then correcting the problem might be as straightforward as reverting to the use of a suitable aluminum anode. To further protect the vulnerable parts of the end-caps, we could also consider painting a band near the hull o-ring groove to seal it from contact with seawater.

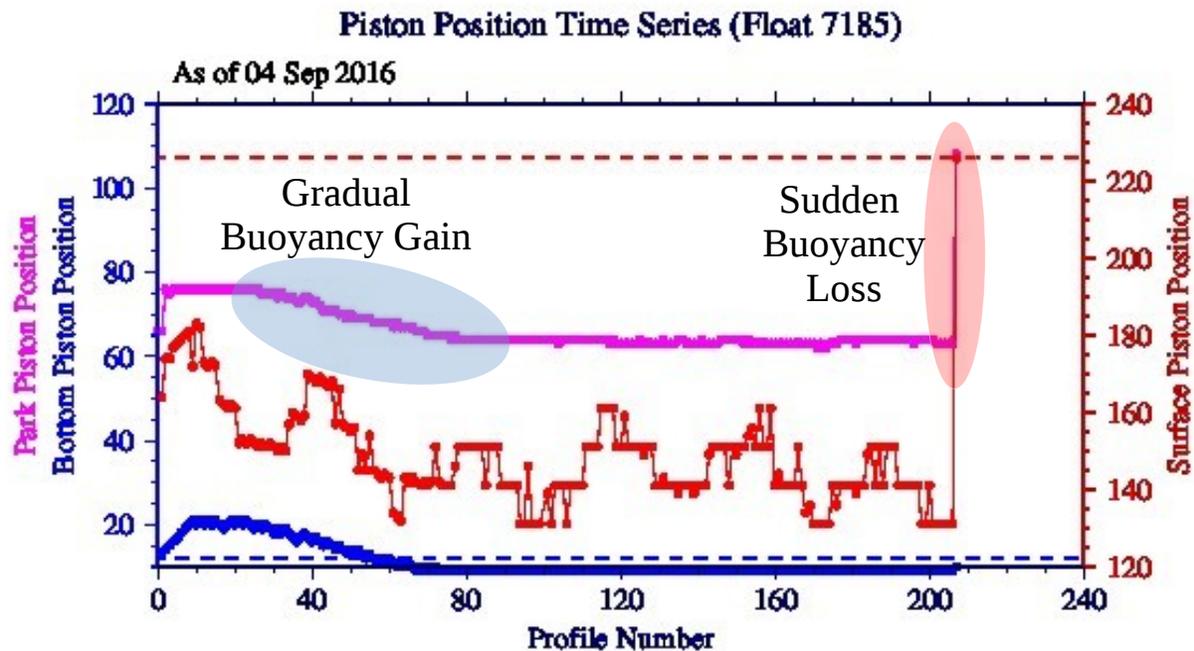
Figure 2: The magenta curve measures the float's buoyancy during the park-phase of each profile cycle. The blue shaded region corresponds to a gradual gain of buoyancy that is compensated by piston retraction. The red shaded region represents a sudden loss of buoyancy just prior to float failure.

The magenta curve represents a profile-series of the park piston position. Of course, during the park phase, the float actively ballasts itself to maintain the user-specified park pressure (ie., 1000dbars). Hence, the park piston position represents an accurate measure of the float's buoyancy. The shaded blue region in Figure 2 suggests that the float is reducing its buoyancy in order to compensate for a gradual increase in overall buoyancy of the float. Thereafter, the buoyancy remains steady until profile 207 when the float apparently suffers a sudden loss of buoyancy before failing entirely.

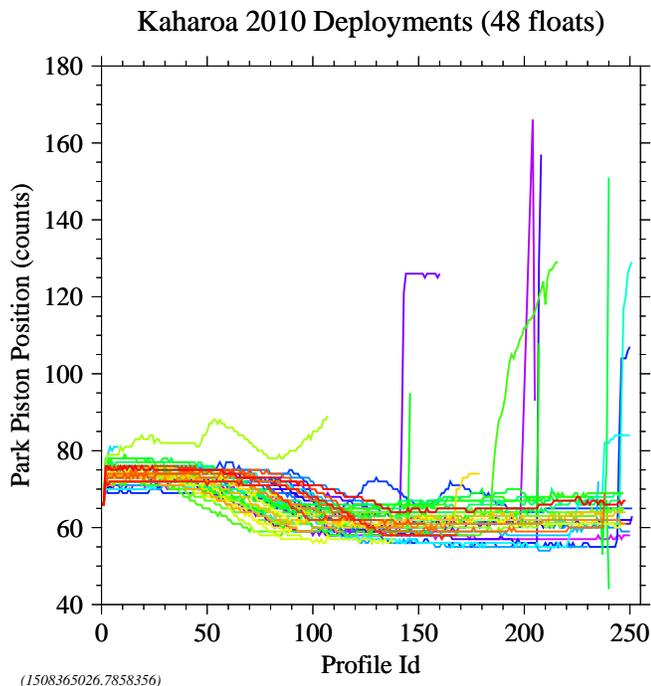
Other explanations for the symptoms shown in Figure 2 can be conjured that do not involve the gain or loss of buoyancy. However, Figure 3 demonstrates that this same cluster of symptoms are widespread and systematic. Forty-five out of the total forty-eight floats in the ensemble that I analyzed exhibit these symptoms. The systematic character of these symptoms renders any alternate hypotheses that I can think of to be not viable.

Figure 3: The profile-series of the park piston position for the ensemble of 48 floats reveals a coherent pattern of gradual buoyancy gain in the span between profiles 35 and 135. The buoyancy gain of 10–15g is surprisingly uniform for all floats except one. This strongly suggests a systematic causal mechanism.

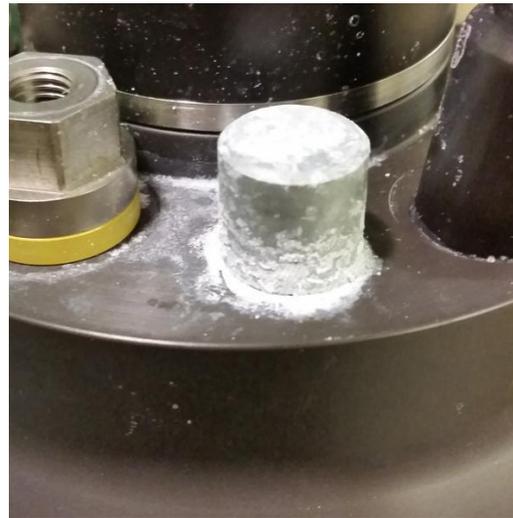
- The protection capacity of zinc is less than that of aluminum. For a given mass, aluminum will protect longer than zinc. The New Zealander that was possession of PMEL's float 3020 reported that no trace remained of the anode.
- Some zinc alloys have higher galvanic potential than 6061 aluminum from which the hull and end-caps are made. Obviously, such a zinc alloy won't work because the aluminum is more anodic than the zinc.
- Zinc can self-protect by forming a nonconductive scaly crust. Figure 4 shows an anode that has started to form this crust after only brief exposure to saltwater.

Figure 4: A white scaly crust has started to form on this anode after only brief submersion in saltwater.

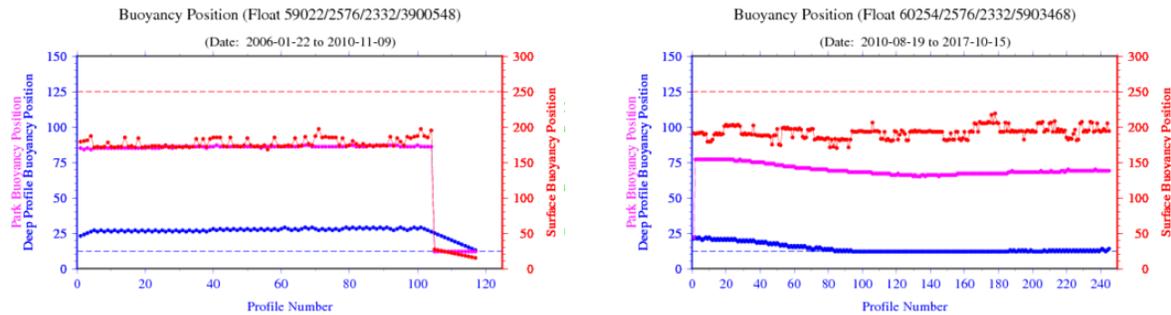
The left plot of Figure 5 shows the profile-series for the first deployment. Note that the park piston position remains steady throughout the mission until profile 104 when the float drifted into shallow water. The symptoms of the syndrome are completely absent during this deployment.

The right plot of Figure 5 shows the profile-series for the second deployment. The park piston position remains steady at 77 counts for the first 28 profiles after which it gradually decreases to 65 counts at profile 130. This 12-count change is very consistent with the gradual increase in buoyancy of UW floats as shown in Figure 3.

Figure 5: PMEL Apex (WrcId) 2332 was deployed, recovered, refurbished, and redeployed. No wet parts were replaced during the refurbishment except for the anode. Symptoms of the syndrome are absent in the first deployment but present in the second.

For these two missions executed by the same float, the parts in direct contact with seawater differed only due to replacement of the anode. This constitutes pretty convincing circumstantial evidence that the anode was the root cause of the gradual increase in buoyancy that is characteristic of this syndrome. It strongly suggests that the change in anode material happened sometime between 2006 and 2010.
