REPORT FROM THE 1st ARGO TECHNICAL WORKSHOP
September 19-21, 2005
University of Washington, Seattle, USA
[prepared by S. Riser and S. Wijffels]

3. Failure Modes of APEX Floats

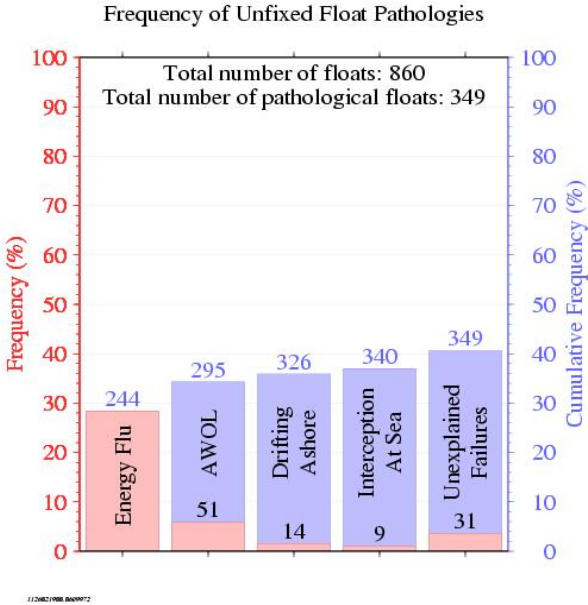
As noted, several of these problems have been fixed. Yet the largest source of failure by far, alkaline energy flu, generally remains as a problem. Several fixes for this problem have been suggested, but it is not clear that these remedies have yet been successful (see Figure 2).

Figure 2: Frequency of float failure due to currently unfixed problems based on the analysis of the failure of 366 APEX floats (supplied by Dana Swift., UW).

Based on this analysis, the following steps are recommended in order to improve float lifetimes:

1. Use the *Park and Profile* feature (ie, do not go to 2000 m on every profile), particularly if using alkaline batteries (see below).
2. Deploy away from islands and coasts.
3. Monitor the engineering data from each float on each profile (this can be automated).
4. Avoid deployments of large numbers of floats with of new features until the performance has been documented (the motor backspin problem is an example of this, where large numbers of floats profiling to 2000 m were deployed before this capability was fully tested by the manufacturer and the user community).

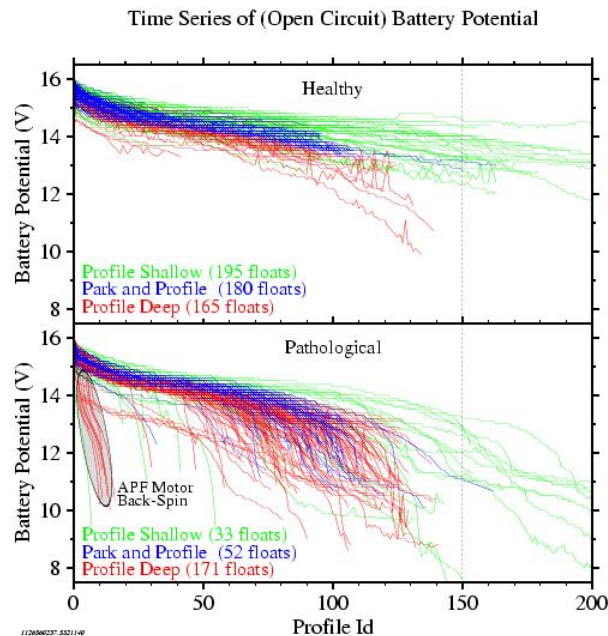
Based on laboratory testing done at UW, an APEX float with alkaline battery packs should achieve 300 shallow (1000 m) profiles, 220 park and profile cycles (to 1000 m on three out of four profiles, and to 2000 m on the fourth), 160 2000 m profiles. Note that one reason for the larger number of shallow profiles is that a lighter weight hull can be used, allowing an additional battery pack be carried by the float. However, many floats are not meeting these theoretical projections. An analysis of the battery voltage records from the float ensemble clearly shows that floats with alkaline batteries that profile to 2000 m on every cycle consistently showed premature battery failure, and failed prematurely in greater numbers than floats that only profiled to 1000 m (see Figure 3).

Figure 3: Battery voltage as a function of profile number. Top – floats operating normally. Bottom – floats exhibiting energy flu (from D. Swift, UW).

It is now believed that running the float pump at high pressure results in high peak currents drawn from the battery packs. These currents are thought to cause individual alkaline cells in the battery packs to fail; once a cell fails, its high impedance breaks the circuit in the battery pack and the energy in the pack becomes inaccessible to the float.

- 1. Do not profile deep as often.** Deep profiling requires pumping at high pressures and causes high peak currents to be drawn from the battery packs. By reducing the frequency of deep profiling, damage to alkaline cells is reduced. This is clearly indicated in D. Swift's analysis showing higher longevity of alkaline powered floats that do not profile deep frequently. Hence, if alkaline battery packs are to be used alone, we recommend that floats park and profile to 1000 m, with a 2000 m profile only every fourth cycle.

- 2. Install lithium batteries.** Lithium batteries do not suffer from failure under high peak currents and do not exhibit energy flu. CSIRO has been replacing two alkaline packs with lithium batteries since 2000. Among 61 APEX floats powered by such mixed packs, none have shown evidence of energy flu, even the 18 which have profiled over 80 times to 2000 m. Similar results have been obtained by UW and PMEL in younger floats. UW now uses lithium batteries exclusively.

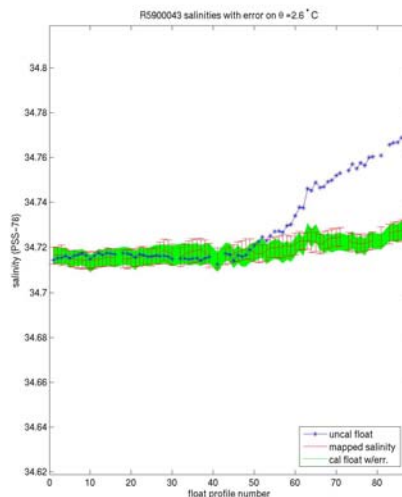
Figure 5: An example of a salty drift error in salinity reported by an SBE41 on an Australian float. Salinity is shown on a deep isotherm, with red showing climatological values and green for corrected values at the float (supplied by T. Tchen, CSIRO).

While most conductivity sensor problems will cause the salinity to drift to low values, a significant number of SBE41s on APEX have drifted *high* – sometimes by as much as 0.1 (PSS-78). In the UW ensemble, 22 floats exhibit this behavior. Australia has 5 floats with clear drifts to higher values of salinity. Physically, this can only occur if the conductivity cell is bored out (the volume of water in the cell is increased) or becomes coated with a substance more conductive than seawater; both of these scenarios seem somewhat unlikely. Alternatively, these errors could be generated by a warm drift in temperature of between 0.1 – 0.01°C, which would not be easily detectable in the data. Appendix D contains a table of examples identified with a slow salty drift error. We believe that these errors are correctable in delayed-mode analysis, as they appear well behaved – that is, constant for each profile and slowly changing in time.

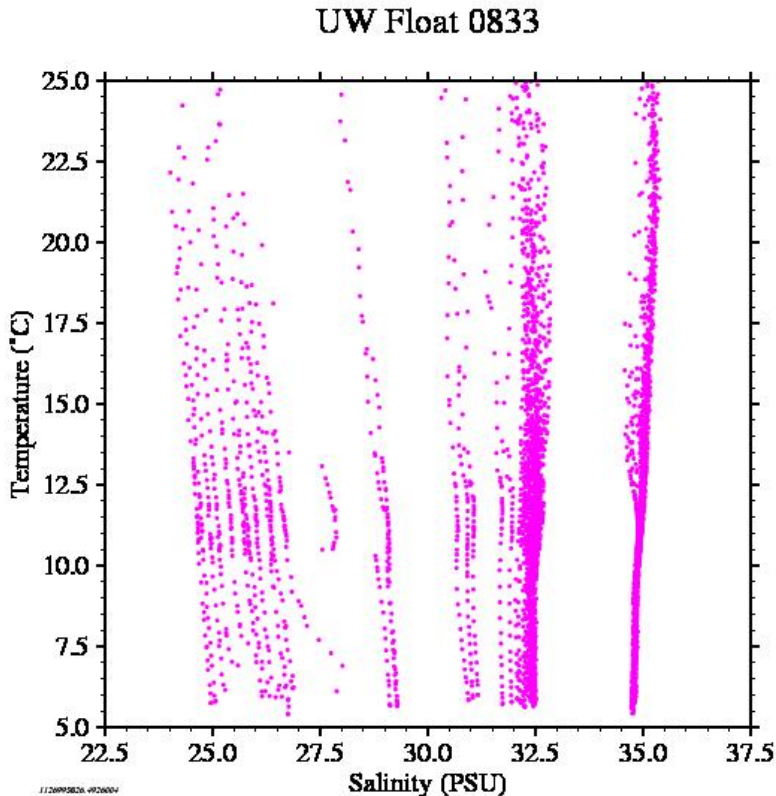
Jumps in Salinity: In the UW study ensemble, 26 floats exhibited large (~1 PSU) jumps in salinity during their lifetime, as shown in Figure 6. Presently, we have no understanding of the possible causes of such an error. As the salinity jumps are very large and the shape of the potential temperature/salinity curve changes, these data are currently deemed uncorrectable.

Figure 6: Example of large jumps in salinity reported by an SBE 41 over a number of profiles (D. Swift, UW).

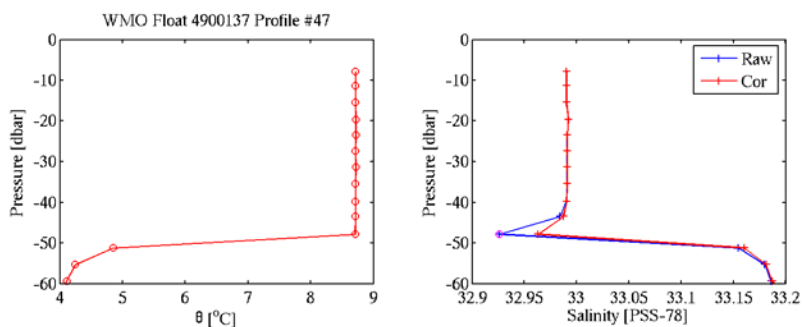
Figure 7: Temperature verses pressure (left) and salinity versus pressure (right) for a float exhibiting a thermal lag error. Note the 0.05 PSU fresh spike at the base of the mixed layer.

On APEX floats, we typically only profile when the float is rising, which means that the conductivity cell is usually colder than the water entering it. During its passage through the cell, the water is cooled by thermal diffusion at the cell wall, resulting in lower conductivities (a

difference of 0.001°C leads to a salinity error of 0.001 PSU) and thus lower calculated salinities. The salinity error scales with the rate of change of temperature with time. Thus, errors will be largest when a float is passing through very strong temperature gradients, such as found at the base of the mixed layer (Figure 7) producing spikes in salinity of over 0.05 PSU. Also of concern is that this error is a fresh BIAS error that exists all through the profile. While for most of the water column the error will be very small (< 0.001 PSU), in the tropical thermocline bias errors can be as large as -0.005 to -0.01 PSU. G. Johnson showed that this error is correctable to some extent, and he showed examples of how this might be done. The accuracy of the correction relies on knowledge of temperature change with time. For continuously sampling CTD units (the SBE 41CP) a correction could be made on board in the instrument software, while for the more common burst sampling done by SBE41 units, the correction will have an error due to imperfect knowledge of temperature changes over the seconds before a sample is taken. It is recommended that we routinely do this correction in delayed mode. This problem and its potential future solutions were discussed in more detail with SBE.

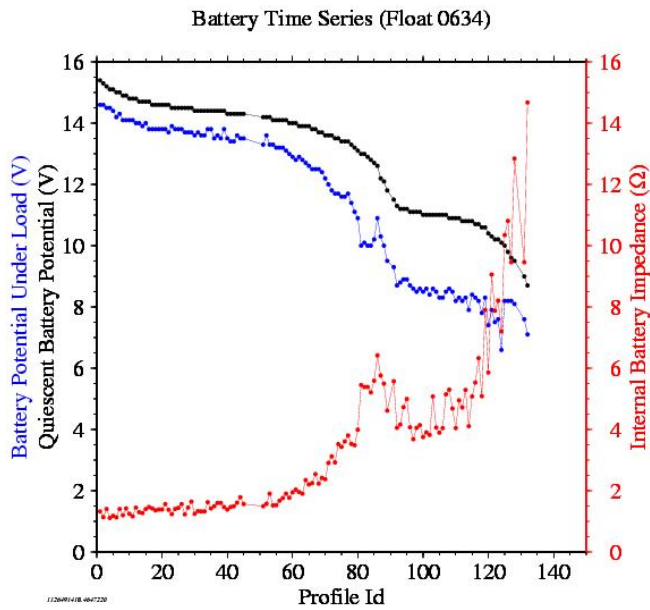
Appendix A. Diagnostics for Alkaline Energy Flu

Alkaline energy flu can easily be seen in the voltage data returned by APEX floats. Voltage will drop quickly over 5-6 profiles and then plateau again. The plot below shows a typical example (from D. Swift).

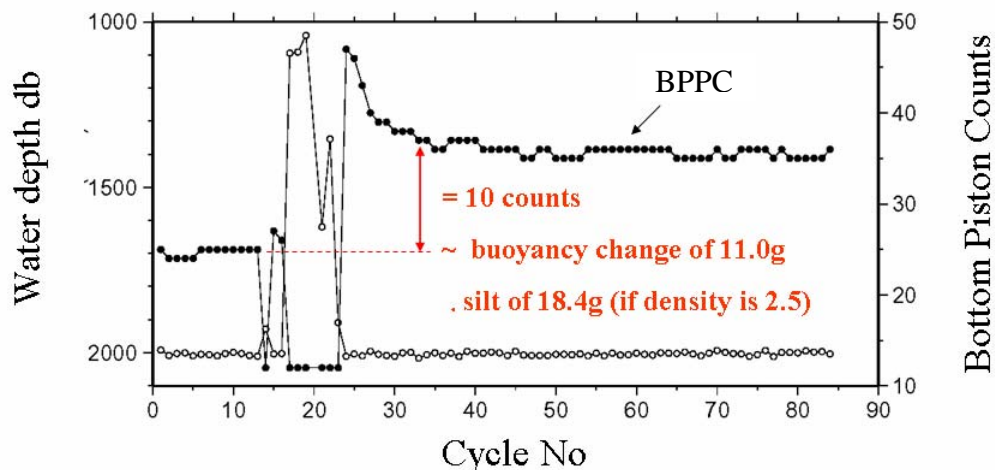
Appendix B. Diagnostics for a Float Grounding or Adding Sediment

Grounding can be detected both in the pressure data and also in the bottom piston position counts (BPPC). If the float collects sediment during grounding events, this will be detectable in an increase in the BPPC once the float has moved back into deep water. As the float is heavier with its sediment load, the float piston does not have to retract as far to reach the drift depth. Above is an example from N. Shikama of JAMSTEC.

Once this problem was recognized, WRC began plugging all but 7 of the holes in the float cowlings to reduce this hazard. JAMSTEC noted that failure due to grounding is now reduced to only 1% of grounded floats.

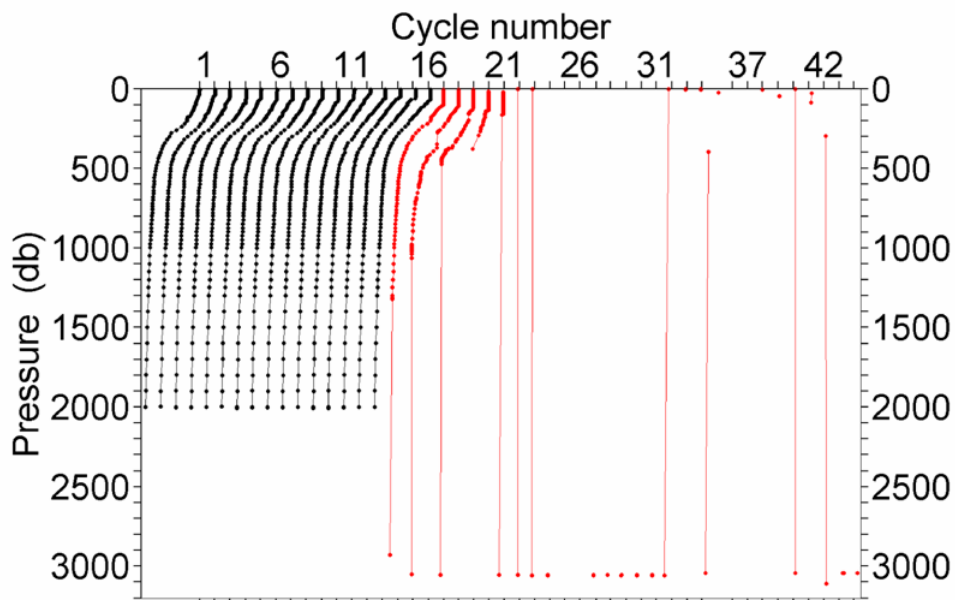
Appendix C. Diagnostics for Druck Pressure Sensor Failure

This plot shows the temperature and pressure data returned by a SBE-41 affected by the Druck sensor failure (supplied by N. Shikama, JAMSTEC). The earliest manifestation can be seen in the full-scale pressure readings near 3000 dbar around cycle 16. The float continues to measure pressure correctly sporadically until cycle 21. Eventually the pressure reading remains stuck at

full scale; the float tries to get to its park depth (1000-2000 dbar) by extending the piston until it becomes a surface drifter and ceases to operate.

Having identified the problem in August 2003, SBE was very prompt in recalling affected CTD's. Druck and SBE have implemented changes to reduce the occurrence of shorts in the sensor, though complete elimination of the problem is seemingly impossible. Since the problem was fixed, a few newly deployed floats (about 1%) have continued to show the Druck problem, but its occurrence is clearly greatly reduced. Many floats deployed before 2003 are still vulnerable to the development of snowflakes, leading to float failure. Hence, we expect to see continued occurrence of failures due to this problem into the foreseeable future.
