REPORT FROM THE 1st ARGO TECHNICAL WORKSHOP
September 19-21, 2005
University of Washington, Seattle, USA
[prepared by S. Riser and S. Wijffels]

3. Failure Modes of APEX Floats

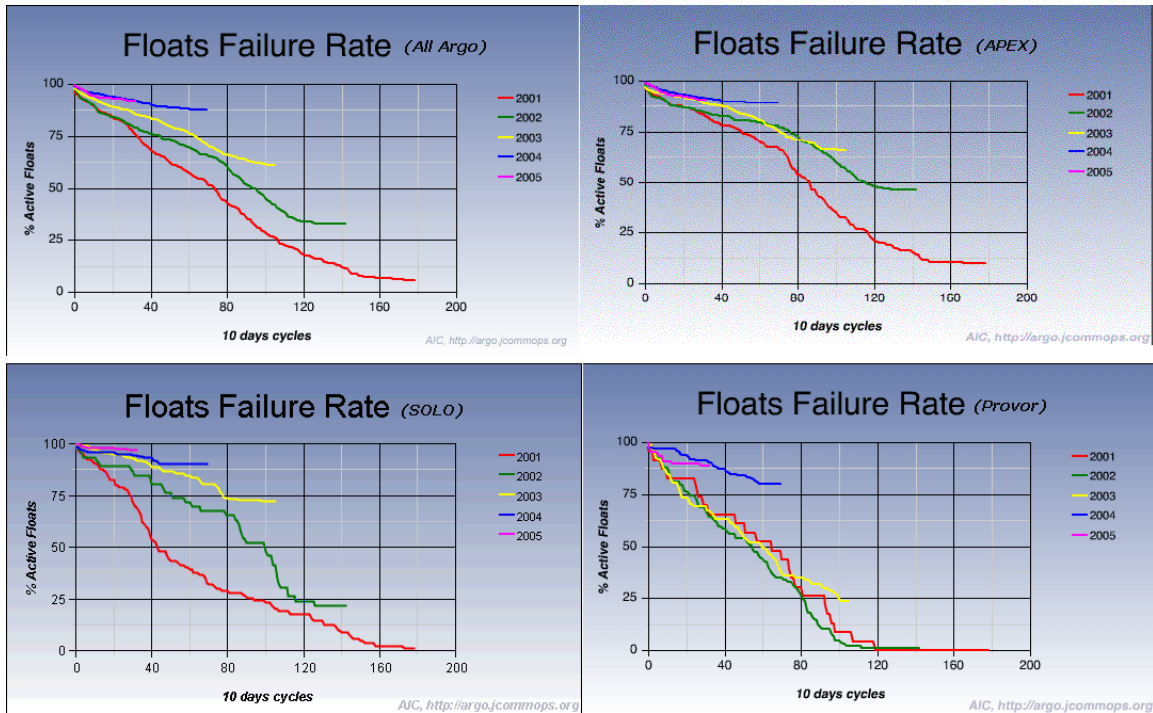
Figure 1: Float reliability (number of profiles delivered as a percent of the number expected) as a function of time and deployment year for APEX, SOLO, and Provor floats (this figure was provided by M. Belbeoch; an earlier version was shown at the meeting).

Due to the problems listed above, only 60-70% of early APEX floats (those deployed in 2001-2003) were operating after 1-2 years (see Figure 1). APEX floats deployed by the University of Washington (hereafter UW) during these years were substantially more reliable (over 80%), most likely due to UW floats parking at 1000 m and profiling to 2000 m only every fourth profile. This practice greatly reduced the loss of floats due to the motor backspin defect, which was only a problem on floats profiling to 2000 m on each cycle. While it is desirable to collect as much 2000 m data as possible, in this case the choice of conservative missions that limited deep data collection to occasional profiles clearly had the effect of increased float lifetime.
